The example of using long-term monitoring and non-invasive measurements for Structural Health Monitoring. Cause study of wall-paintings in St. Anna's Church in Warsaw.

Katarzyna Górecka¹, Sławomir Łapiński^{2*} and Jakub Markiewicz²

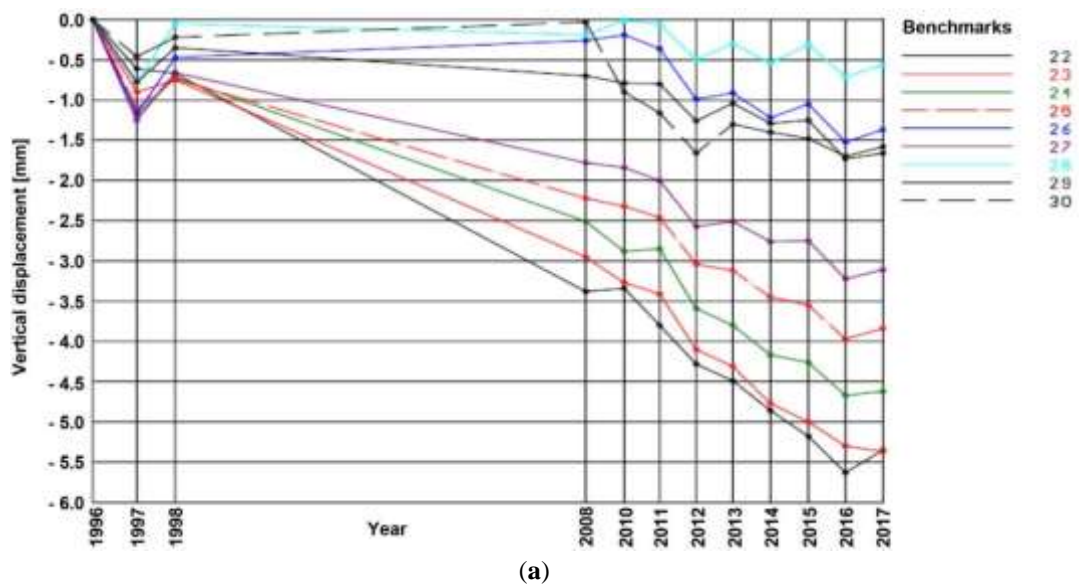
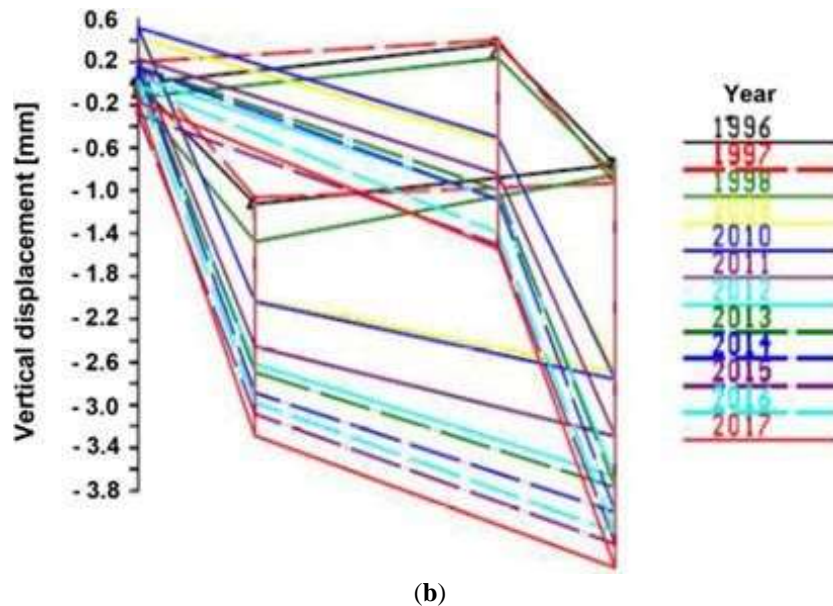
Figure 4. (a) Diagram of vertical displacement of the benchmarks on the tower side; (b) The diagram of the vertical displacement of the tower through the years [44].

The measurements were taken with a digital precision automatic leveller with a bar-code level rod. The processing of the measurement results included the following steps: (1) Pre-alignment of observations, (2) Identification of fixed reference points, and (3) Calculating vertical displacements based on the alignment of observed differences between the initial and current measurements. The study of the constancy of the reference benchmarks between the archival measurement and the current measurement was based on the analysis of the apparent displacements determined in the process of free alignment of observed differences. The final alignments of observation differences, aimed at calculating the displacements of the controlled benchmarks, were carried out using the indirect method with the adoption of a flexible reference system, with a base formed by reference points identified as fixed reference points. Examples of vertical displacement diagrams of selected benchmarks and the tower are shown in Figure 4.

- from -2.6 mm to -1.4 mm in Loretto Chapel (benchmark no.15-18),
- from -3.1 mm to -2.3 mm in St.Ladislaus Chapel (benchmark no.19-21),
- from -2.3 mm to -2.0 mm in the buttresses of the apse on the side of Trasa W-Z (benchmark no. 22-24),
- from – 1.5 mm to – 0.3 mm in the buttresses of the apse on the east side (benchmark no. 252-28),
- from – 1.8 mm to – 1.0 mm in the presbytery (benchmark no. 52-south side and benchmark no. 51-south side),
- from – 2.1 mm to + 0.4 mm in the tower (benchmark no. 1-4), tilt of 1.3mm towards the W-Z Route exit over a period of 8 years,
- from – 1.7 mm to + 2.2 mm in the upper retaining wall (benchmark no. 39-46), uplifts occur in the upper part of the slope and in the lower corner,
- from – 3.0 mm to + 2.6 mm in the lower retaining wall (benchmark no. 55, 56), monitored from 2010r.

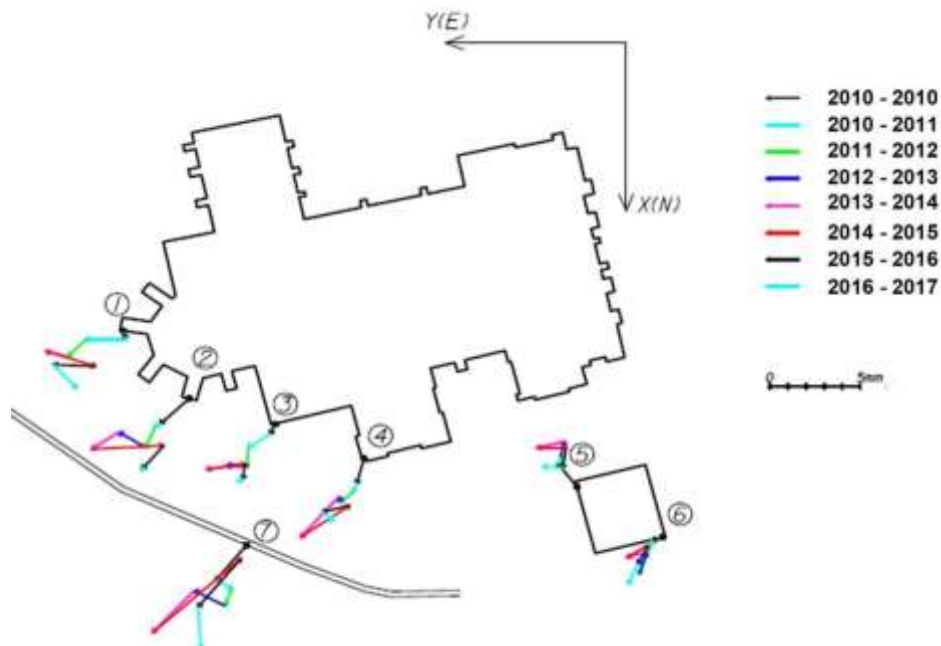
Figure 6. The sketch of horizontal displacement vectors (survey 2009-2017) [44].

The values of the components of the horizontal displacement vectors were determined in the free alignment of the differences in observations between the 2010 year and 2017. Figure 3.1 shows the horizontal displacement vectors concerning the surveyed objects in annual cycles. Note the changing directions of the displacement vectors in the period 2014-2015-2016 - measurements in 2015 were made after a drought lasting several months. The 2017 measurement was taken after 2 months of rainfall. The horizontal displacements of the Church and tower in 2016-2017 are not outside the uncertainty range of their determination. The following is an evident Displacement trend of the retaining wall - total displacement since 2010 is 6.7 mm.

The vectors of horizontal displacements, determined since February 2010, correspond to thermal changes and the intensity of precipitation during the analysed study periods. Note the changing directions of vectors of displacements in the period 2014-2015-2016. The return trend visible in the period 2014-2015 may reflect the impact of a prolonged drought - in 2015 on the condition of the slope. The length of the Church's horizontal displacement vector since 2010 reaches 4mm, and the displacement of the retaining wall - in the central cracked section – reaches 6.7mm.

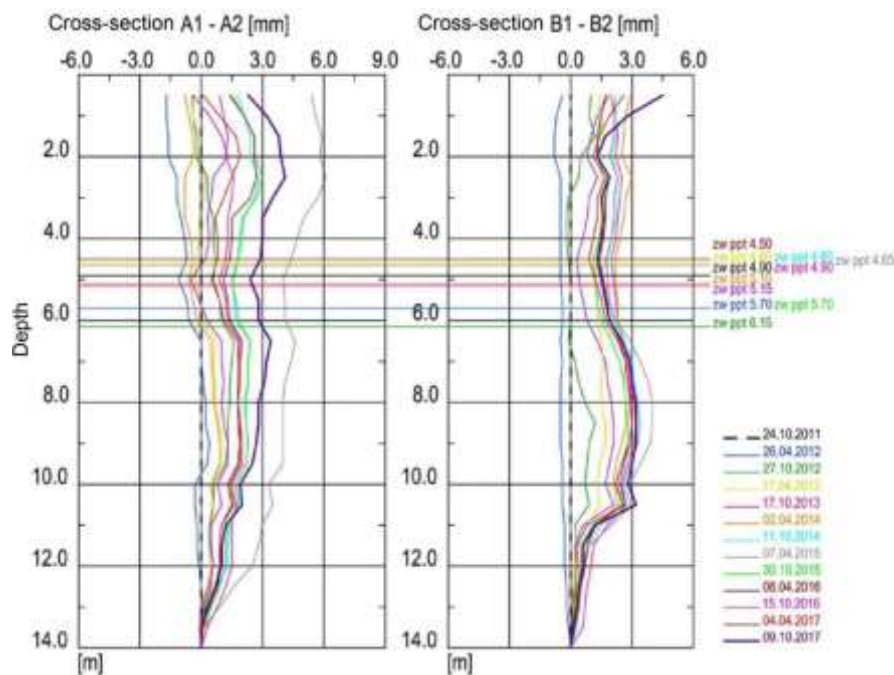
Figure 8. The inclinometer No. 1; horizontal displacement relative to slope base [44].

The analyses carried out show that the magnitudes of the absolute horizontal displacements of the inclinometer column heads not exceed the uncertainty range of their determination. However, they confirm the non-occurrence of significant displacements of inclinometric columns.

A summary of the observations of inclinometers 1, 2 and 3 indicates a northeastward displacement trend of the soil slightly exceeding the uncertainty range of its determination. The cumulative relative horizontal displacements in column 4, periodically exceeding the uncertainty interval of their determination, may be due to measurement errors caused by a twisting of the shape of this column.

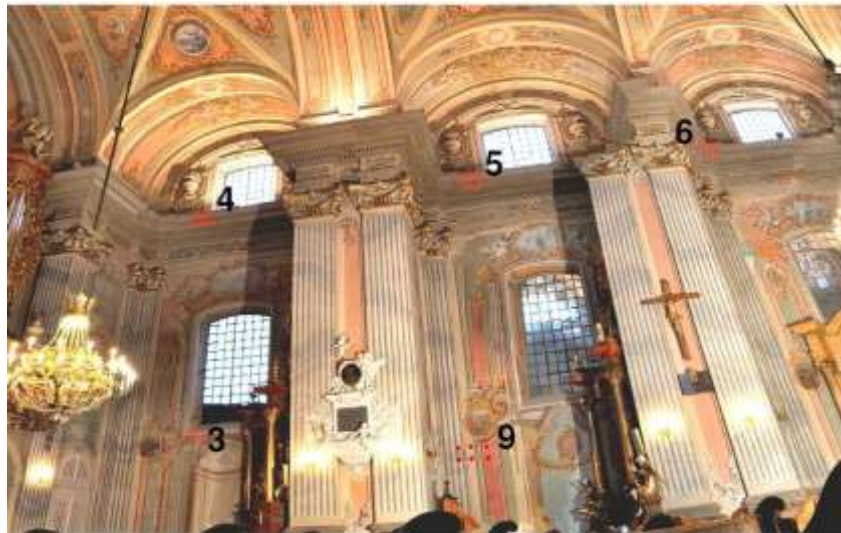
Figure 9. The example of the location of the measuring points in the nave (points 4 - 5) and of the bark gauges (points 3 and 9) [45].

In order to analyse the size of the crack and determine the size of the cracks, it was decided to use direct measurements using crack gauges and measurements using a total station (Figure 9).

Observations of changes in the width of cracks on the walls and vault of the nave, apse and the chapel of St Ladislaus indicate the instability of the body of the Church. Measurements of the bolt crack gauges, set up in the vault of the nave on the side of the attic, have been carried out since 14 March 2014. The effects of temperature on crack opening. The most significant changes are found in the north side's central part of the vault.

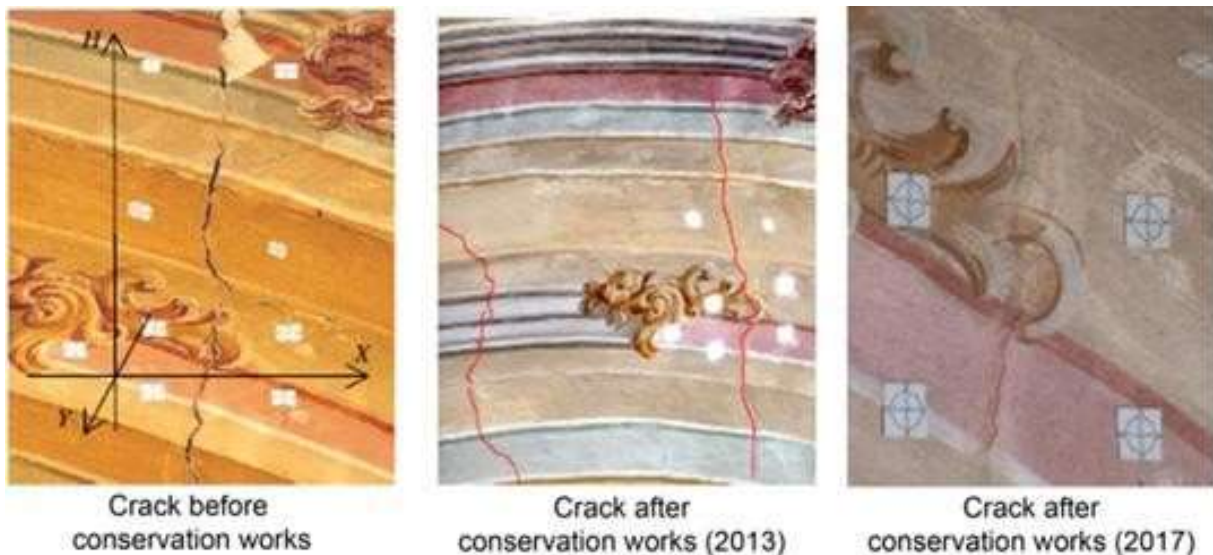
Figure 10. The example of the configuration of measurement points around a crack before and after conservation work [44].

Changes in the width of fractures not available for direct measurement were determined by observing retroreflection points stuck in the fracture region. The observations were made from free-standing positions, and the final values of relative displacements in the region of the controlled crack were obtained by local transformations (using the Helmert method) of the x,y,h coordinates of the observed points. Examples of the location of the measurement points in the area of the investigated cracks are shown in Figure 10. The table 1 summarises the values of the relative displacements in 3 directions: X (north), Y (east) and H (height).
