The example of using long-term monitoring and non-invasive measurements for Structural Health Monitoring. Cause study of wall-paintings in St. Anna's Church in Warsaw.

Katarzyna Górecka¹, Sławomir Łapiński^{2*} and Jakub Markiewicz²

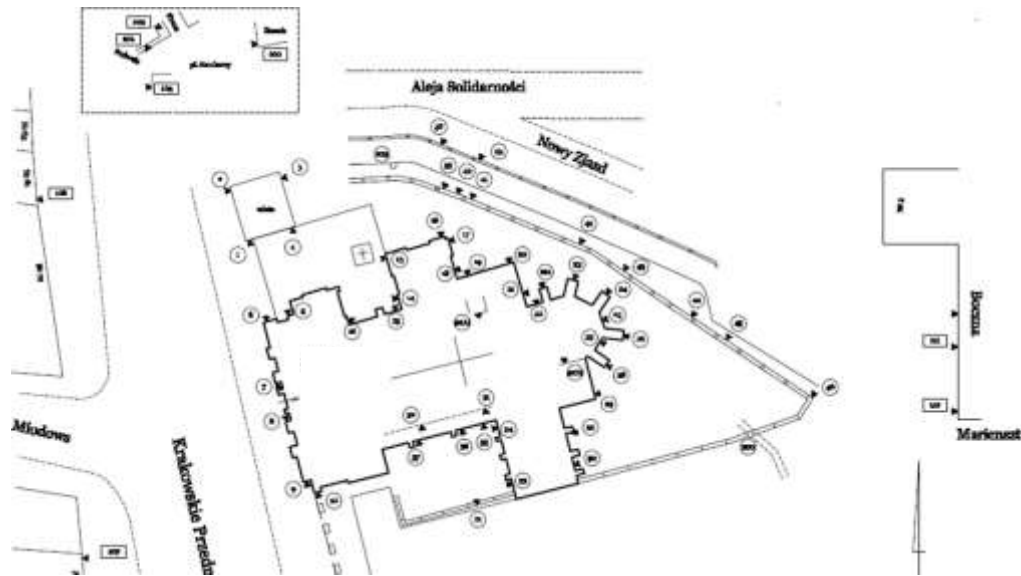
Figure 3. The sketch of the location of benchmarks for the determination of vertical displacements [44].

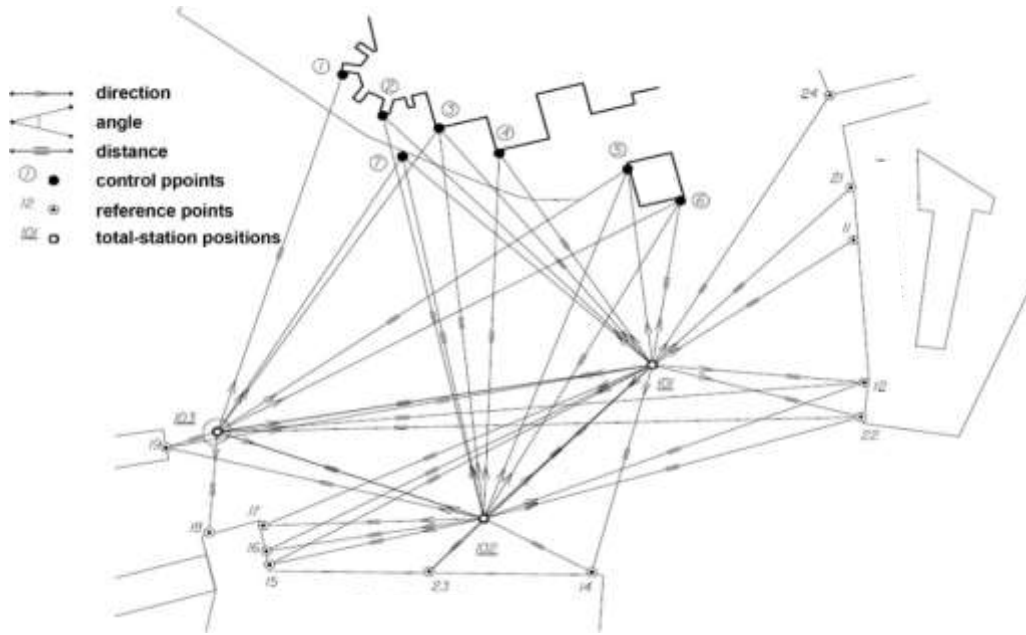
Figure 5. The sketch of an angle-linear network for horizontal displacement determination [44].

The values of the components of the horizontal displacement vectors were determined in the free alignment of the differences in observations between the 2010 year and 2017. Figure 3.1 shows the horizontal displacement vectors concerning the surveyed objects in annual cycles. Note the changing directions of the displacement vectors in the period 2014-2015-2016 - measurements in 2015 were made after a drought lasting several months. The 2017 measurement was taken after 2 months of rainfall. The horizontal displacements of the Church and tower in 2016-2017 are not outside the uncertainty range of their determination. The following is an evident Displacement trend of the retaining wall - total displacement since 2010 is 6.7 mm.

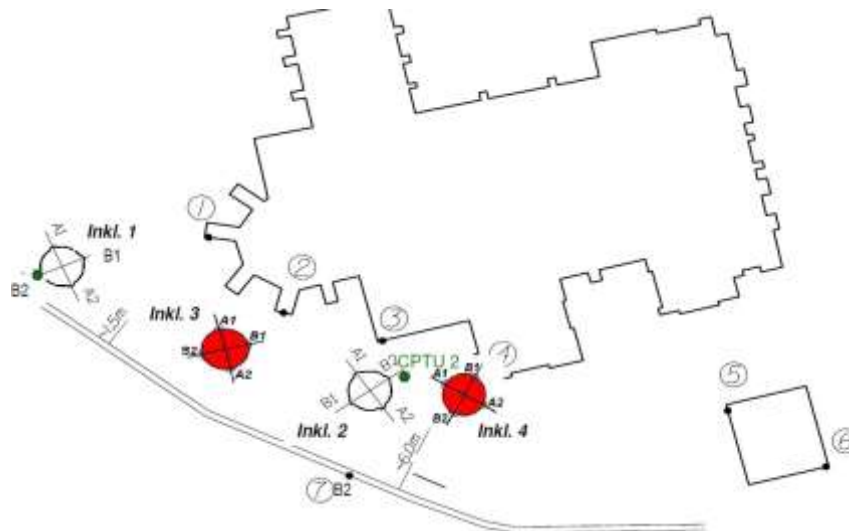
To detect possible landslide movements in the slope of the hill of St Anne's Church, observations of inclinometers No. 1 and 2, located at a depth of 14 m, have continued since 2011, and since 2012 inclinometers No. 3 and 4, located at depths of 21 m and 25 m respectively (Figure 7). In 2017, measurements were taken on the 4th of April after a mild winter characterised by below-average precipitation/. The location of the inclinometric columns in the slope is shown in Figure 7. Examples of the results of inclinometric measurements in column 1, in the directions marked in Figure 7, are shown in Figure 8.

Figure 7. The sketch of inclinometer column arrangement [44]. Inclinometers 1 and 2 are seated at a depth of 14m, while inclinometers 3 and 4 are at depths of 21m and 25m, respectively.
